9.0 Lakeview, Oregon, Disposal Site

9.1 Compliance Summary

The Lakeview, Oregon, Uranium Mill Tailings Radiation Control Act (UMTRCA) Title I Disposal Site, inspected on June 24 and 25, 2008, was in good condition. The U.S. Department of Energy (DOE) continues evaluation of the durability of the disposal cell erosion control rock riprap and the infiltration of water into the cell. No cause for a follow-up or contingency inspection was identified.

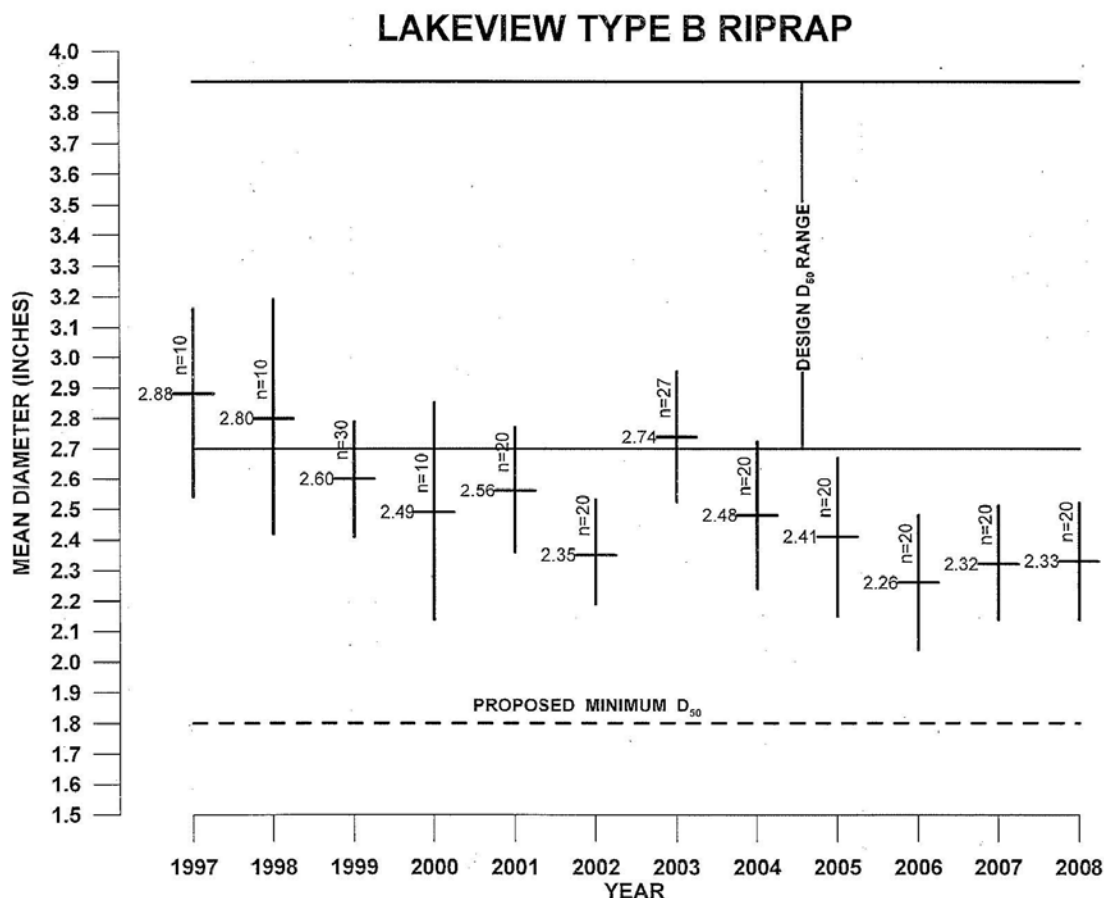
Figure 9-2. Side Slope Riprap Size Monitoring Results for the Lakeview Disposal Site

Gradation monitoring was performed on the riprap during the 2008 inspection of the west side slope for the 12th consecutive year (PL-5). Particle size distribution (weight percent) by count data was collected at 20 locations. An evaluation of the rock size measurements taken in 2008 indicates that the side slope riprap D_{50} is 2.33 inches with a 95 percent confidence interval between 2.14 and 2.52 inches (Figure 9-2).

The 2008 result of 2.33 inches basically replicates the 2007 result of 2.32 inches. Annual values measured for the previous 5 years include the following: 2003 (D_{50} = 2.74 inches), 2004 (D_{50} = 2.48 inches), 2005 (D_{50} = 2.41 inches), 2006 (D_{50} = 2.26 inches), and 2007 (D_{50} = 2.32 inches). The mean D_{50} for the previous 5 years (prior to 2008) is 2.44 inches. The D_{50} values show a slightly upward trend since 2006, but overall, the cover rock size D_{50} from 1997 to the present has gradually decreased by about 20 percent. The initial, more rapidly decreasing trend may be because the basaltic rocks used on the side slope were predisposed to chemical or physical weathering and reacted more quickly to newly imposed surface conditions

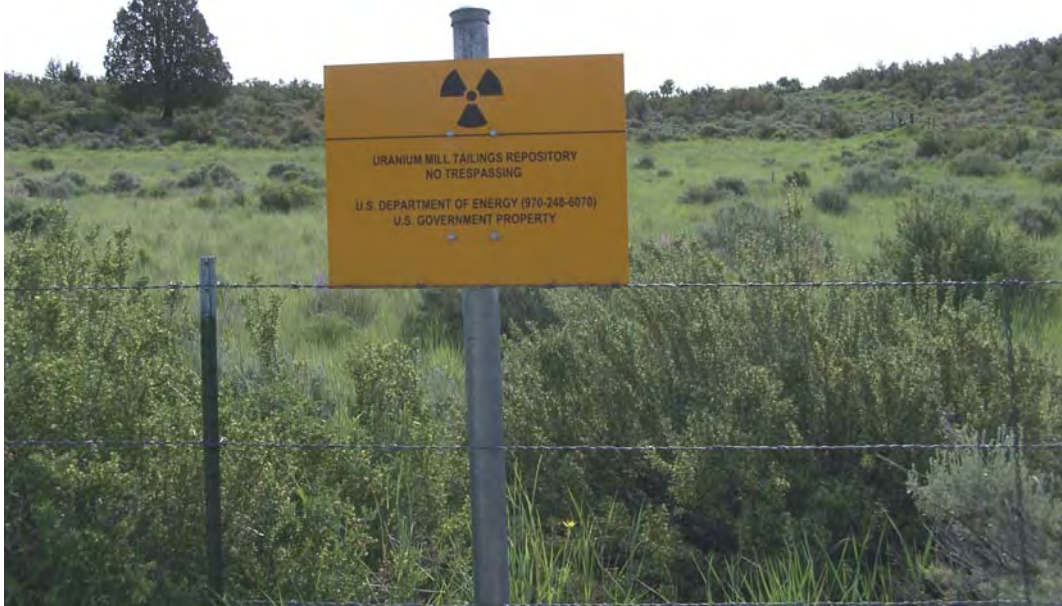
The entrance sign was in good condition. Two perimeter signs (P10 and P12) were replaced during the 2008 annual inspection (PL-1). The remaining 10 perimeter signs were in good condition. Perimeter sign P1 was obstructed by vegetation. It will be cleared or the sign will be moved during the next inspection.

LKV 6/2008. PL-1. New perimeter sign P10.

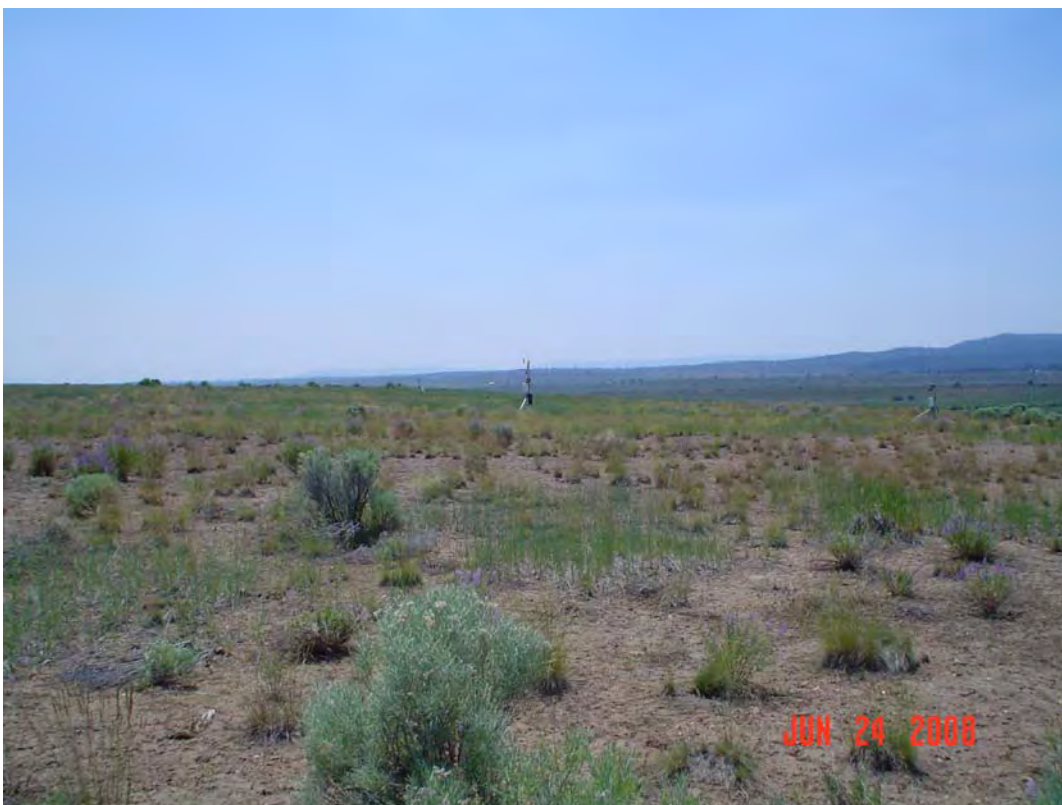
The top slope was seeded with grasses, but the low water-storage capacity of the thin (nominal 4-inch-thick) topsoil layer has limited grass growth to scattered patches of deeper-rooted wheat grasses. The total vegetative cell cover has gradually increased over the years as patches of deeper-rooted grasses have spread (PL-2). Perennial and annual species, although limited, are also establishing on the cell top. Most of the top slope still has sparse vegetation compared to surrounding undisturbed plant communities, and bare areas still exist.

Movement of precipitation through the riprap and bedding layers and into the radon barrier also favors the growth of shrubs. Sagebrush, rabbitbrush, and bitterbrush, which are the dominant plant species surrounding the site, have been establishing on the top of the disposal cell. Shrub density likely will continue to increase until it approaches or exceeds levels observed in native plant communities adjacent to the site.

LKV 6/2008. PL-2. Disposal cell top.

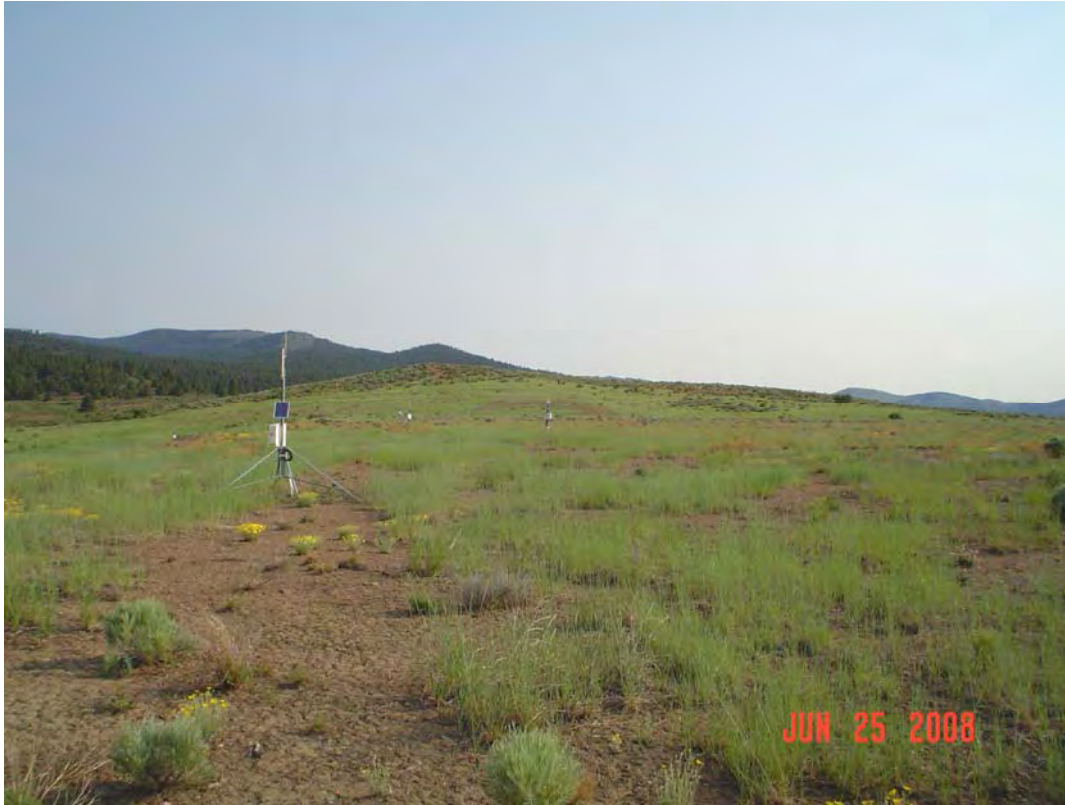
In fall 2005, LM began an evaluation of a new device called a water fluxmeter (PL-3), a passive wicking lysimeter, to directly measure percolation flux through the Lakeview disposal cell cover. Three water fluxmeters installed in holes augered through the top slope of the cover and into tailings capture percolation just below the compacted soil layer in the cover. Monitoring results show significant percolation through the cover. Cumulative percolation averaged 996 millimeters during 2006, 186 millimeters during 2007, and 444 millimeters during 2008. These values are assumed to be greater than the mean percolation for the cover because the three water fluxmeters were intentionally placed in downslope locations where water accumulates in the sand drainage layers. The evaluation also includes monitoring of moisture content in the tailings. Tailings beneath the side slope of the disposal cell remained saturated during the entire 3-year period. The combination of high percolation flux and saturated tailings raises concerns about the potential for the leaching of contaminants and the protection of groundwater. DOE plans to evaluate the fate and transport of tailings constituents and associated human-health and ecological risks.

LKV 6/2008. PL-3. Water fluxmeter No. 5.

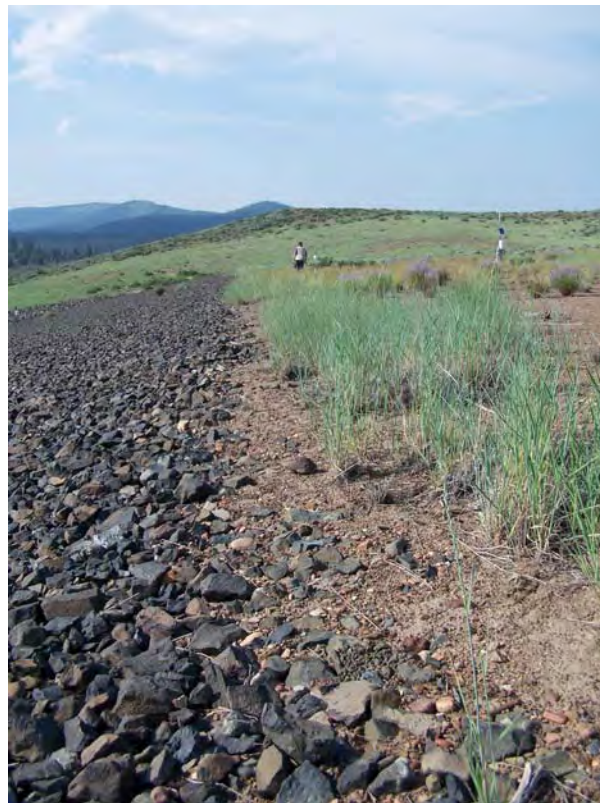
Drains—The side-slope cover shows no sign of cell settlement, displacement, or slumping. The contact boundary between the cell top and side slopes show no evidence of vertical or horizontal movement (PL-4). Concerns about the size and durability of the riprap are discussed below in the “Riprap Condition Evaluation.”

LKV 6/2008. PL-4. Boundary of disposal cell top and west side slope.

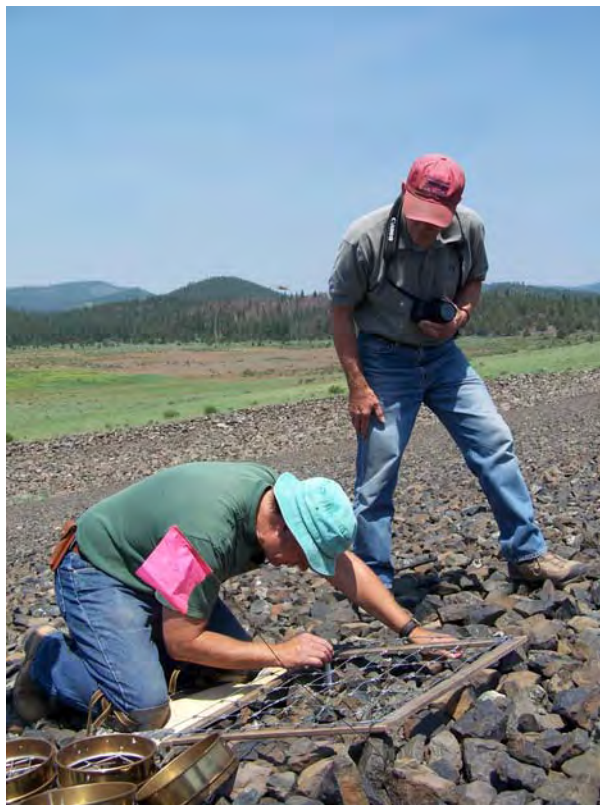
LKV 6/2008. PL-5. Rock gradation monitoring.

9C DOE will initiate annual rock durability monitoring during the 2009 annual inspection to quantify the durability of the existing rock cover by estimating the percentage of rocks that are durable, that are susceptible to near-term degradation, or that have already crumbled. This durability monitoring will be implemented in conjunction with the annual D_{50} monitoring, and the results will be reported in the annual inspection report.
